Ears and Eyes

Without Pictures

Ears and Eyes is a searchable database of cases of physical surveillance devices (microphones, cameras, location trackers...) hidden by law enforcement and intelligence agencies to surveil people or groups engaged in subversive activities.

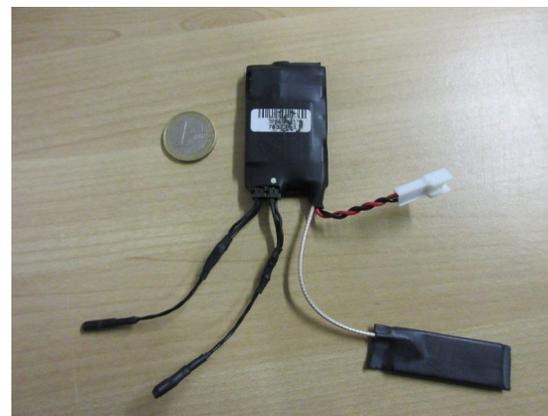
Microphones found inside a power outlet in a building in Bologna, Italy, in January 2018.¹

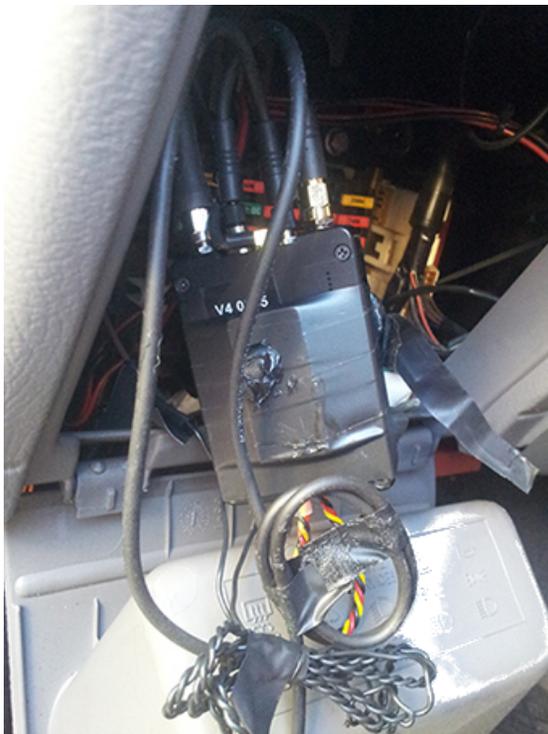
Microphones and a GPS tracker found in the fuse box of a car in Lecce, Italy, in December 2017.²

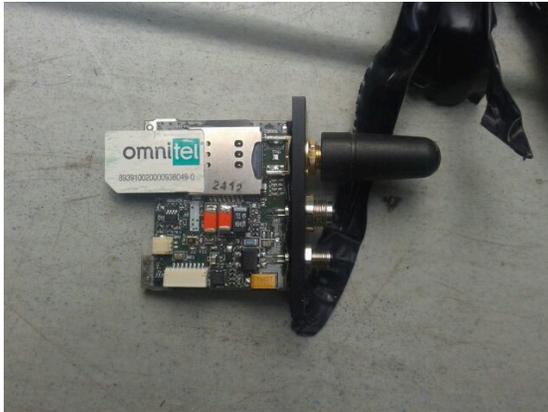
A device equipped with a SIM card found in a vehicle in Italy, in August 2019.⁵

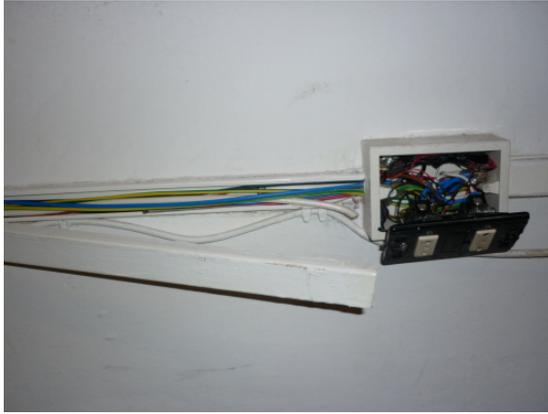
A dismantled electrical outlet in which a microphone was found, in Lecco, Italy, in October 2010.⁶
