Ears and Eyes, Without Pictures

No Trace Project

The *Ears and Eyes* project is a searchable database of cases of physical surveillance devices (microphones, cameras, location trackers...) hidden by law enforcement and intelligence agencies to surveil people or groups engaged in subversive activities. Our goal is to help the potential targets of such surveillance practices to better understand and resist them.

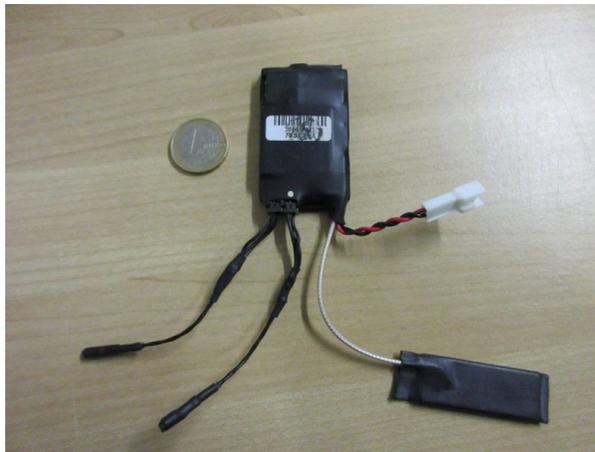
Microphones found inside a power outlet in a building in Bologna, Italy, in January 2018.¹

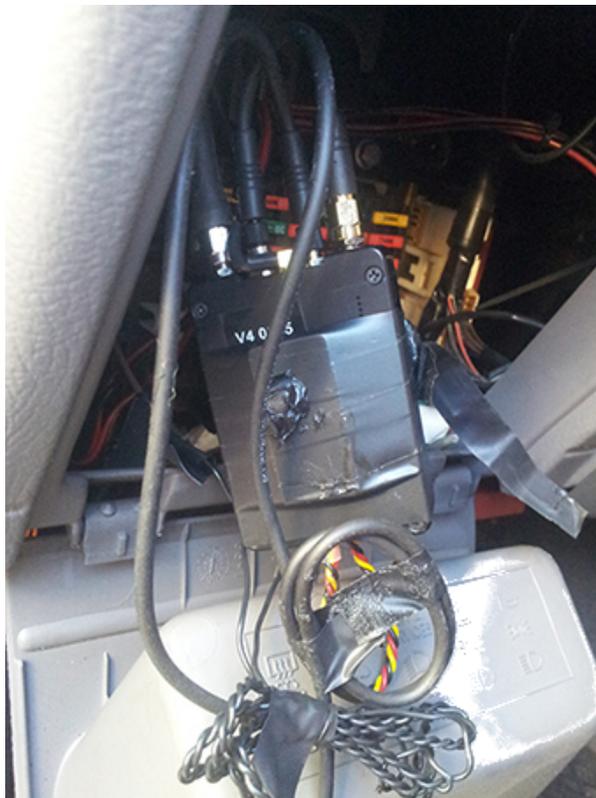
Microphones and a GPS tracker found in the fuse box of a car in Lecce, Italy, in December 2017.²

Microphones and a GPS tracker were found in a car. They were located **in the fuse box**. The car had been having electrical problems (the battery had discharged twice in a month, sign of an abnormal electricity consumption), presumably because of the devices.

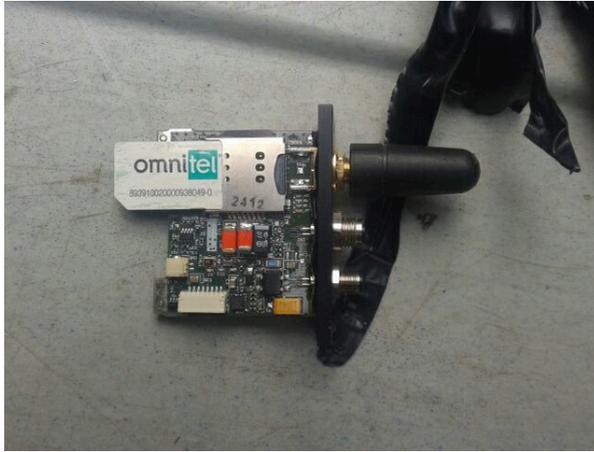
A device equipped with a SIM card found in a vehicle in Italy, in August 2019.⁵
