# Ears and Eyes

## With Pictures

## **Ears and Eyes, With Pictures**

No Trace Project

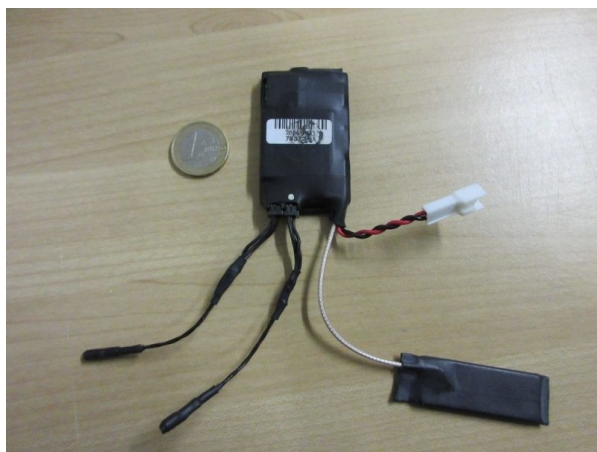
Microphones found inside a power outlet in a building in Bologna, Italy, in January 2018.<sup>1</sup>

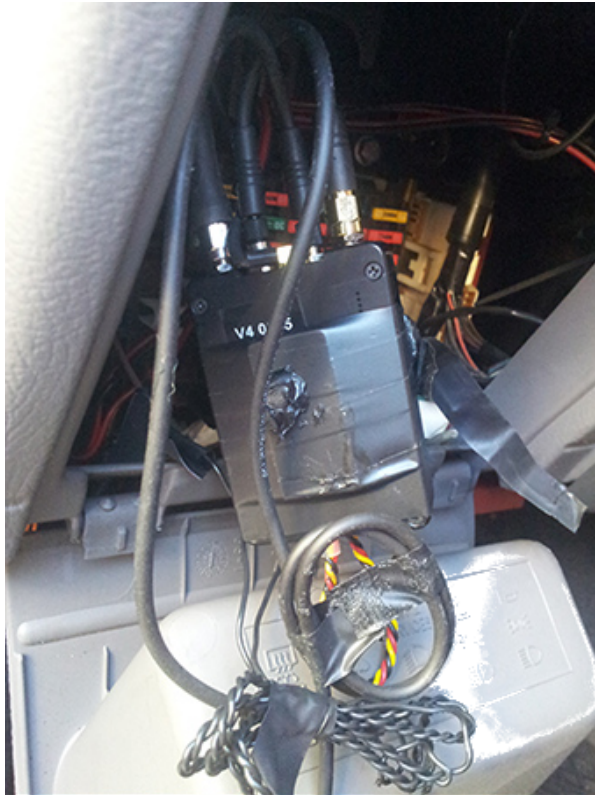
Microphones and a GPS tracker found in the fuse box of a car in Lecce, Italy, in December 2017.<sup>2</sup>

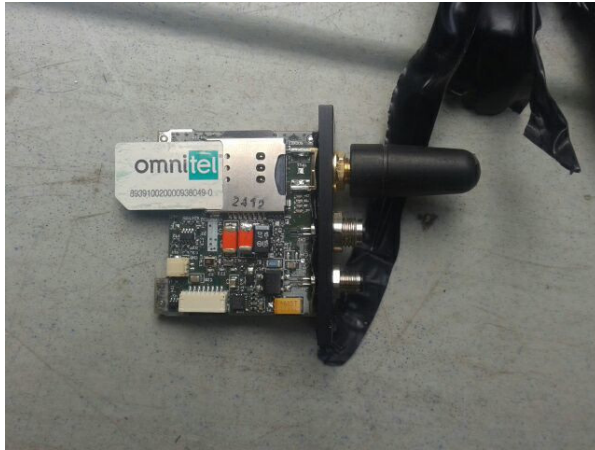
A device equipped with a SIM card found in a vehicle in Italy, in August 2019.<sup>5</sup>

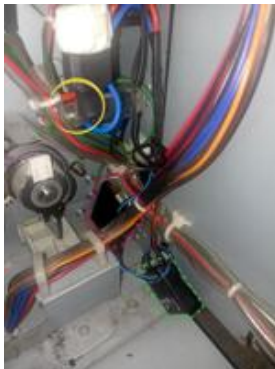
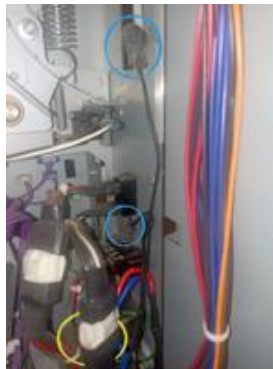
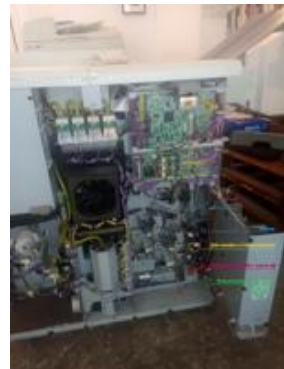
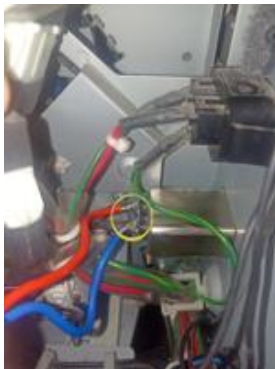
Blue: microphones; yellow: wires soldered to the power supply; pink: small box with SIM card + SD card; green: transformer.

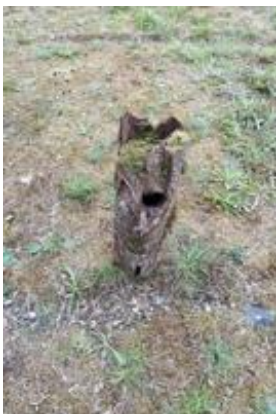
**Four cameras** were found outside a large area where people lived. They were hidden **near an access gate to the area, camouflaged in a fake tree log and fake stones**. They filmed continuously and were connected, via buried cables, to large batteries and concealed modems. The mention “Allwan” was visible on a label on a camera. The cameras were found on August 31, and appeared to have been installed right before a event organized in the area on August 29 and 30.

1: first camera group; 2: portal; 3: second camera group.

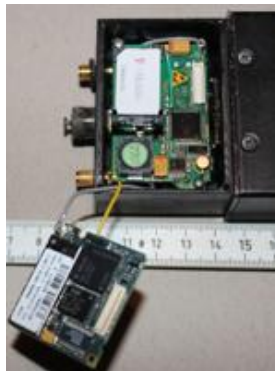
GPS tracker open with SIM card

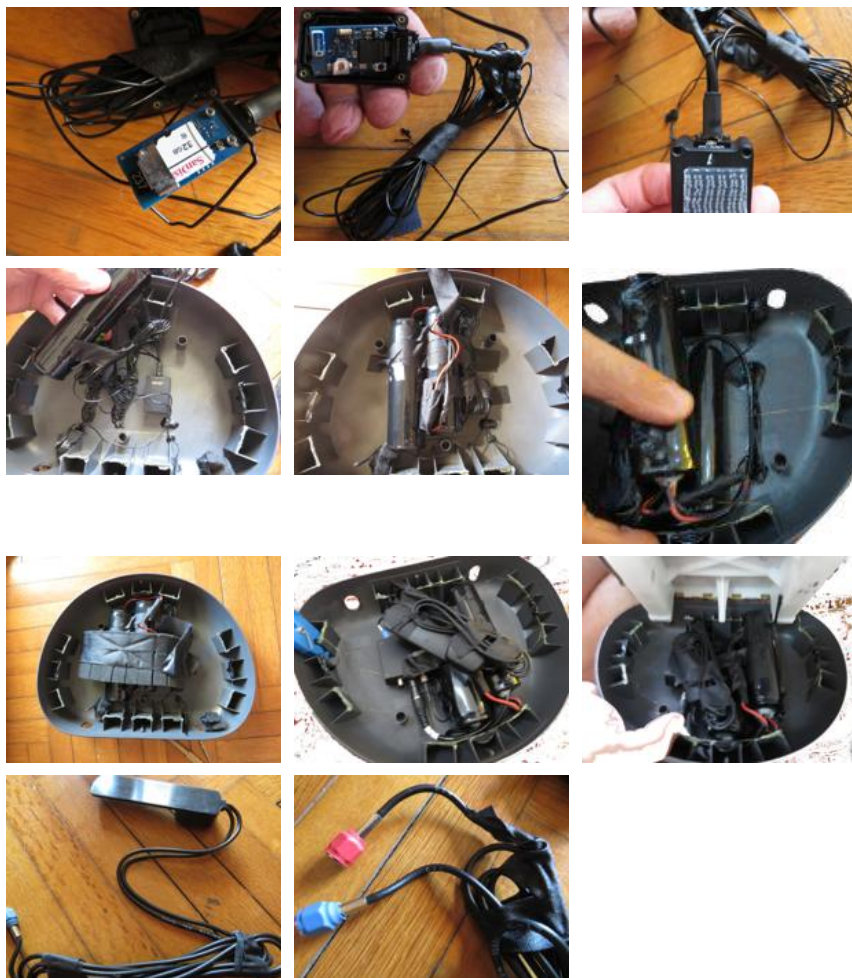
A **GPS tracker and a microphone** were found in a car. The two devices were installed separately, **each in one of the front seat headrests**. The headrests were opened and glued back together after the devices were installed. Each device was equipped with two batteries. The first device, which was apparently the control unit, was equipped with a GSM module to send GPS data and recorded audio files via the mobile phone network. On the control unit were a GPS/GSM antenna, the connection to the batteries and a microphone. Inside the device, a SIM card was found. The second device seemed to be the actual audio monitoring device. It also had a battery connection, a smaller antenna and two microphones, which had been glued into the holes for the seat support, with anti-vibration padding. This device was equipped with an SD card, but there were no more audio files stored in it. The SD card was apparently used as a storage medium for the operating system data and for temporary storage of the recorded data. According to what was known at the time of discovery, the

2: the two batteries of the listening device; 4: microphones connected to the listening device; 6: dismantled listening device; 7: SD card.

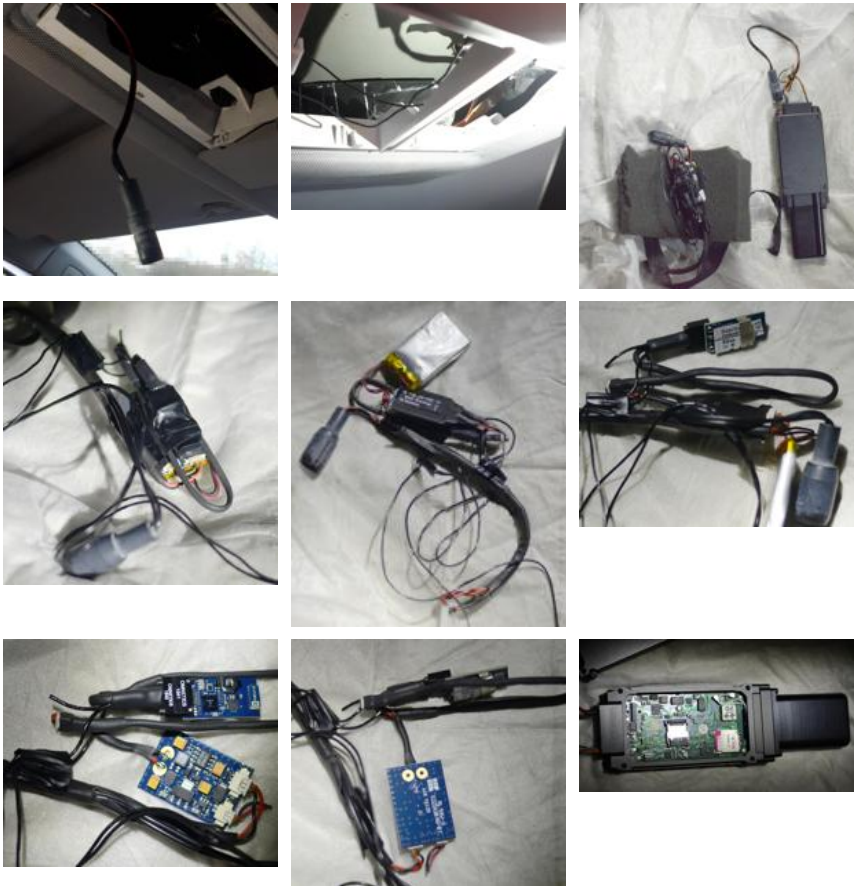
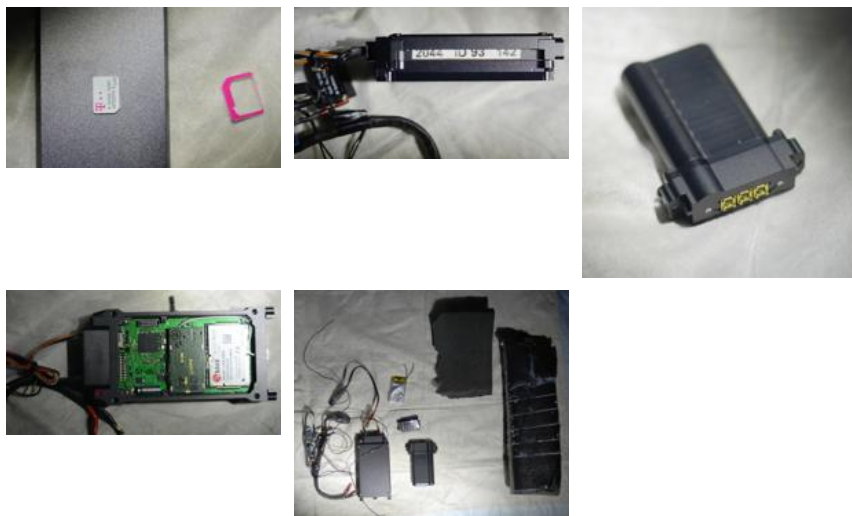
A **GPS tracker** and an **audio recording device** were found in a car. They were located **behind a panel of the front ceiling light**. They were connected by a power cable and drew their power from the supply line to the rear ceiling light. The GPS tracker contained, among other things,

a GPS receiver “u-blox MAX-M8”, a card slot with a 16 GB microSD card, a cellular chip “u-blox LISA-U230” along with a SIM card, as well as a removable three-pin antenna module. The audio recording device contained a voltage converter, a 3.7 V, 550 mAh lithium-ion battery, and a small circuit board which included a 32 GB microSD card and the “NN01-104” antenna from the company Ignion (formerly “Fractus”). The audio recording device tapped into the microphone of the hands-free system, which was located behind a cover above the rearview mirror.

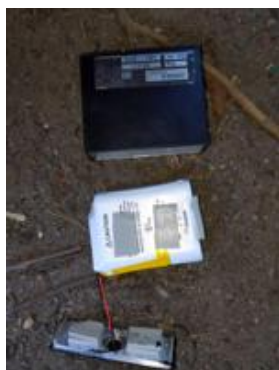
**Two GPS trackers** were found under a vehicle—the second one was found a few days after the first one was found and removed. They were **attached with strong magnets in a hollow space between the bumper's plastic covering and the vehicle body, precisely behind the left rear wheel**. Each tracker consisted of two metal cases connected by a cable. The first one contained a battery pack and the second one the tracker itself, including a smaller battery, two antennas, and a SIM card.

The pictures of the device show it included a tracker of model “NavKos T” marketed by the German company DESAG Telematic. This suggests that the device was supplied by the German company **DESAG Telematic**.

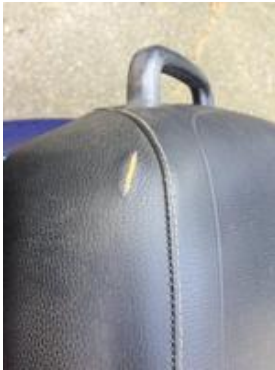
An **AirTag**—a tracking device marketed by Apple—was found on a scooter. It was hidden **inside the scooter seat cushion**, in which it had been inserted through a slit apparently made with some sort of blade. It had an approximate diameter of 3 centimeters and a height of less than 1 centimeter.

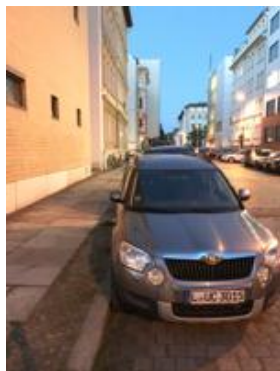
**Two cameras** were found in a car parked on a street. They were located **on the package shelf, in a basket and a bag respectively**. A set of cables, hidden under towels, led to the trunk of the vehicle. The camera lenses were aimed at a building entrance and a sidewalk.

The car, on which signs were put to draw attention to the presence of the cameras (1)

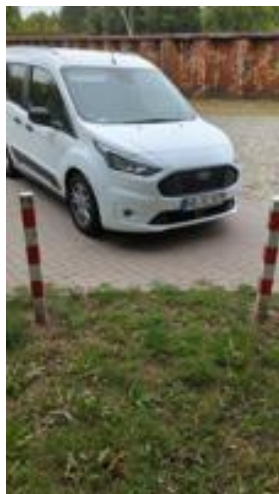
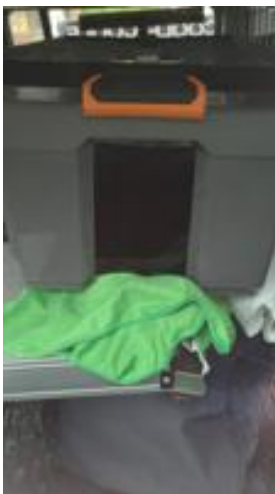
A **camera** was found in a car parked near the venue of an event. It was located **in a box, behind a tinted panel**. It had a good view on the venue's entrance. A flashlight pointed at the box revealed the camera, despite the tinted panel.

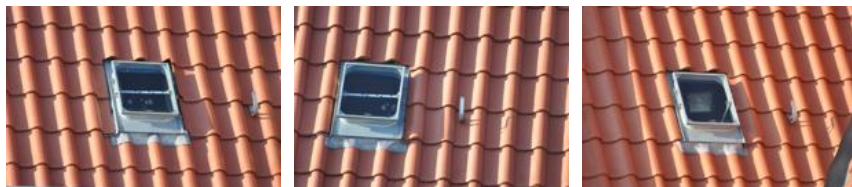
**Several cameras** were found **in the attic of a public school located in front of a recently evicted squat, overlooking the squat through the skylights.**

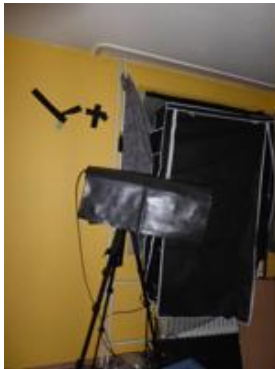
Sony camera (1)

The whole installation was powered from a wall socket using an “Antrax SwitchBox-GSM” device which contained another SIM card, seemingly allowing the installation to be powered on and off through the mobile phone network. The IP cameras were powered by the video management device through Ethernet (using a “Delock Gigabit PoE+ Splitter” device).

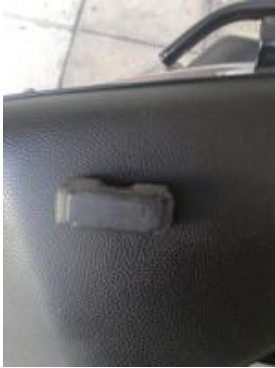
**Microphones and GPS trackers** were found in three vehicles.

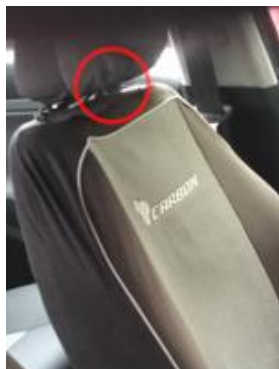
A **camera** was found **in a car parked in front of an apartment building, pointed towards the entrance of the building**. It was located **under the headrest of the driver seat**.

The camera is circled in red

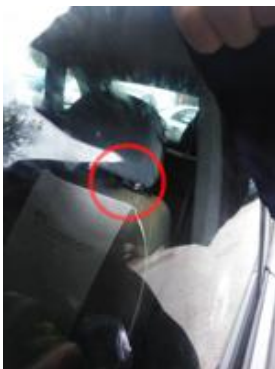
The camera is circled in red

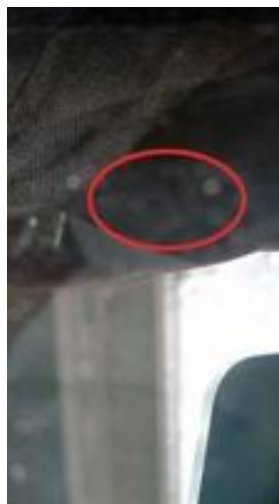
A **camera** was found **in a car parked in front of a house**. It was located **inside the car rearview mirror**. It was connected to wires concealed with a scarf. A few minutes after the discovery of the camera, police officers arrived and arrested the person who discovered it. The person was released after spending 10 minutes at the police station, during which the car disappeared.

The camera is circled in red

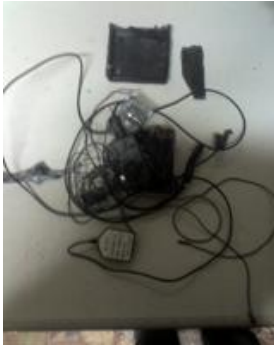
A **GPS tracker and microphones** were found in a car. The device was located **in a plastic container (badly) stuck under the roof**. It contained two boxes, both of which included a SIM card. From there wires went out, through a hole, up to under the back seats. There were two microphones along the seat belt canal: the first at the driver's height, the second at the height of the levers used to adjust the seat, next to the back seats. The antenna was behind the back seat. Finally, still coming from these two boxes, a wire went through the car doors to reach the car fuse box.

Overall view of the device

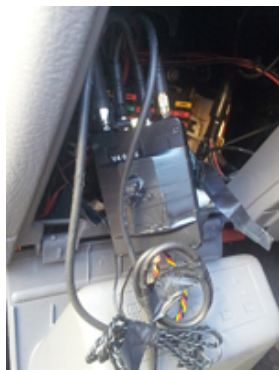
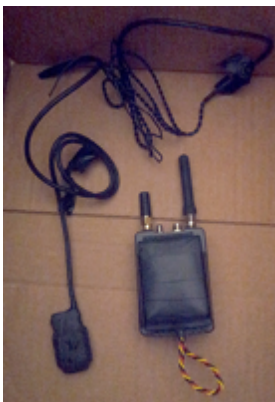
**Microphones and a GPS tracker** were found in a car. They were located **in the fuse box**. The car had been having electrical problems (the battery had discharged twice in a month, sign of an abnormal electricity consumption), presumably because of the devices.

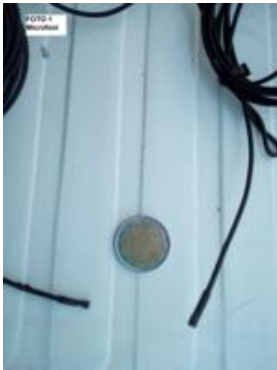
**under the dashboard.** The magnetized GPS and a thing with an antenna and cards were hidden **behind the speedometer.** Everything had been seemingly installed in the car more than a year before the discovery and the microphones were recording even when the car engine was turned off, in a radius of several meters.

The microphones

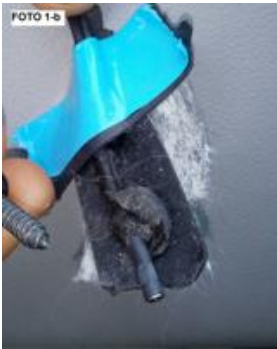
A microphone

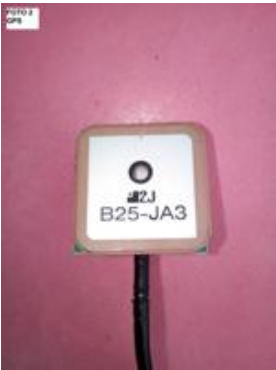
The GPS

The device with an antenna connected to the microphones and the GPS. It also included a SIM and memory card.

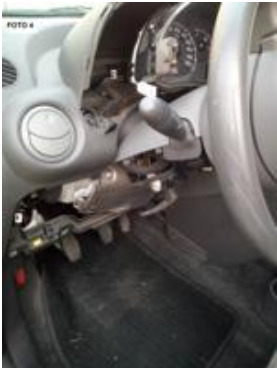
1: behind the speedometer; 2: the fuse box.

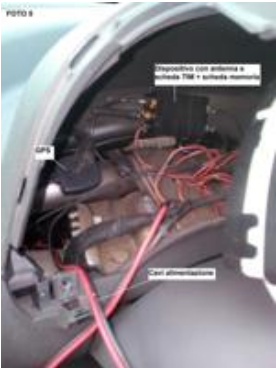
Counterclockwise from top: device with antenna, SIM and memory card; GPS; power cables.

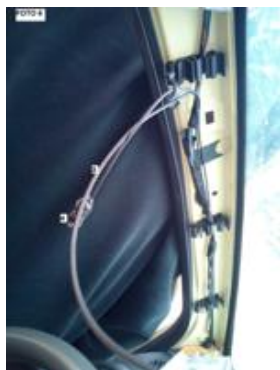
Microphones and their power cable

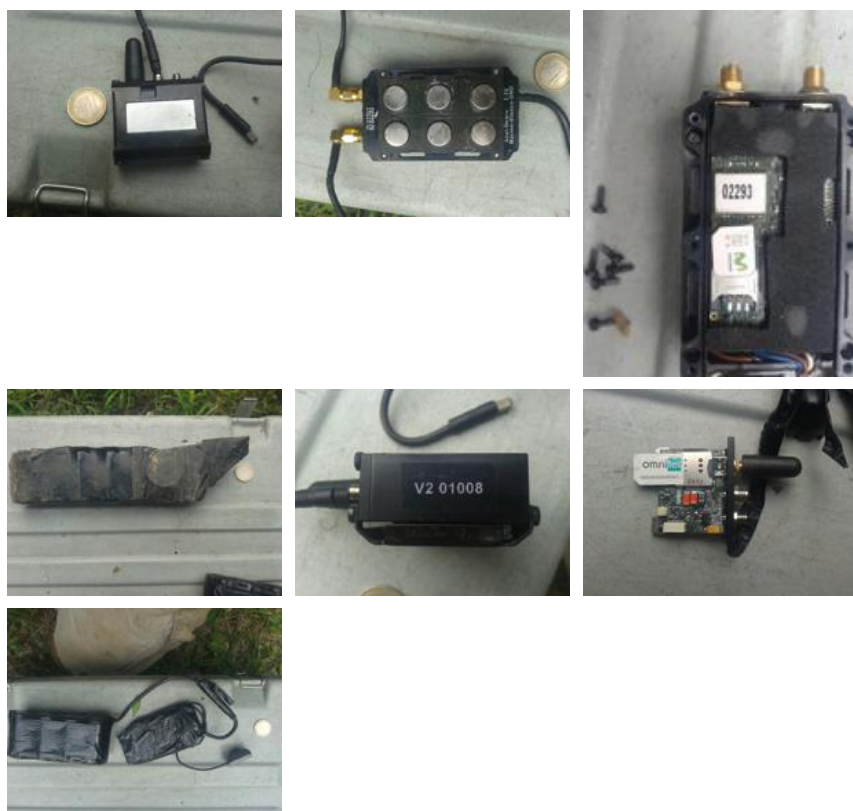
A microphone and two GPS trackers were found in a vehicle. A first tracker was **attached with a magnet to the rear bumper, on the right side**. The other tracker, along with the microphone, was located **in the air vents located between the windscreen flap and the windscreen**. The first tracker included a SIM card and an accumulator made of five 3.6 V lithium batteries connected in a series. The other tracker was equipped with a SIM card.

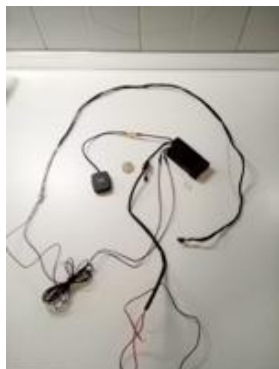
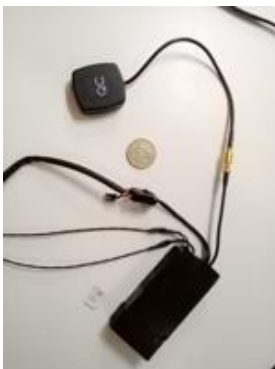
A **tracking device and two microphones** were found in a car. The tracking device was **connected to the power supply of the control unit underneath the steering wheel on the left side**. It was **attached with a magnet, tape, and insulating fabric**. The microphones were located **at the end of a long cable running from the inside of the internal side pillar linings of the windscreen to the underside of the roof of the car**. The tracking device used the GLONASS positioning system, and consisted of an antenna connected to a multi-frequency receiver box containing a micro SIM card.

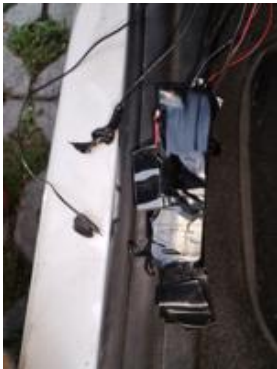
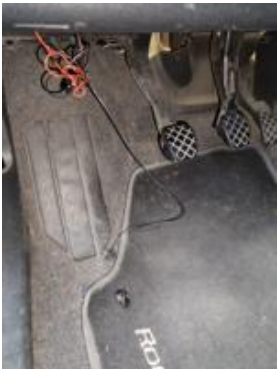
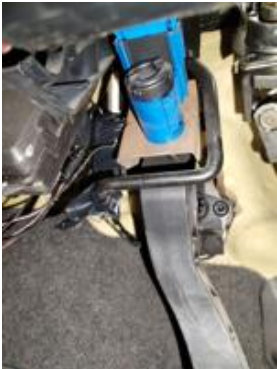
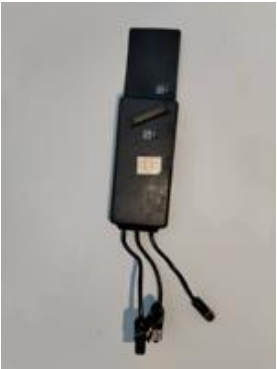
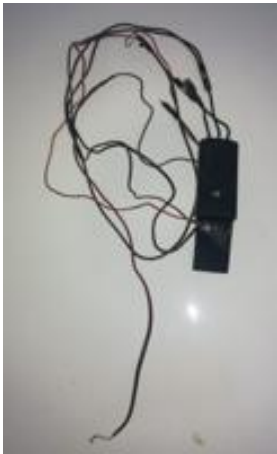
A **microphone** was found in a car. It was hidden **inside the vehicle**. The night before the device was found, one of the car's windows was broken, a few things inside it were stolen, and four men were seen tampering with the vehicle—the theft was presumably a cover-up for the device installation.

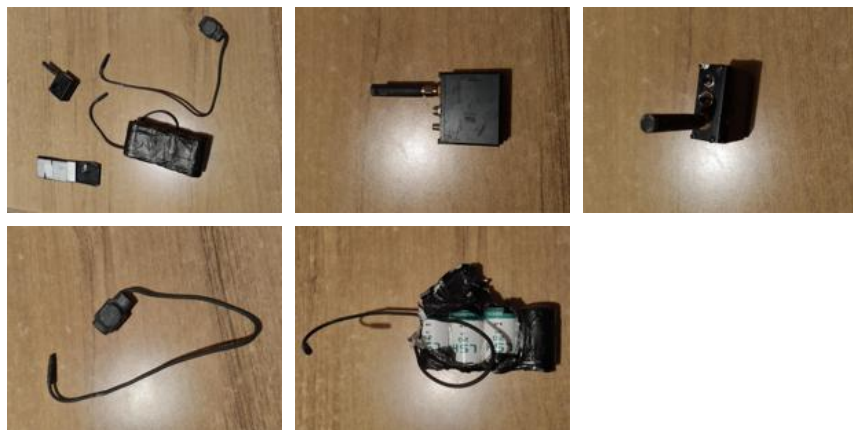
A **tracking device** was found under a car. The battery-powered device was **attached with strong magnets under the car body, in the rear, just past the bumper.**

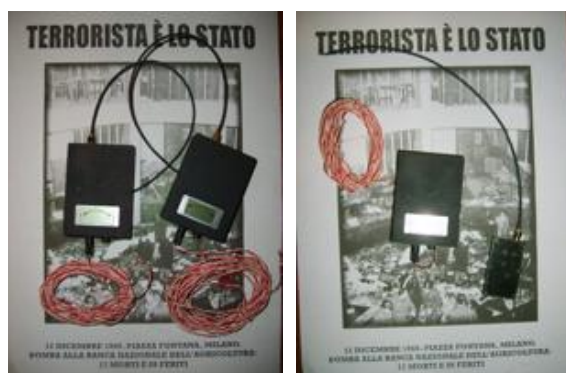
**Two receiver cases** were found in the entry corridor of a building. They were hidden **above a fake ceiling in the entry corridor**. They were connected to the phone line with telephone wires. They consisted in a main unit with a remote-controlled connector, a digital receiver showing the strength of the received signal, and antennas. The presence of the two receivers presumably meant that there were two emitting microphones in the building.

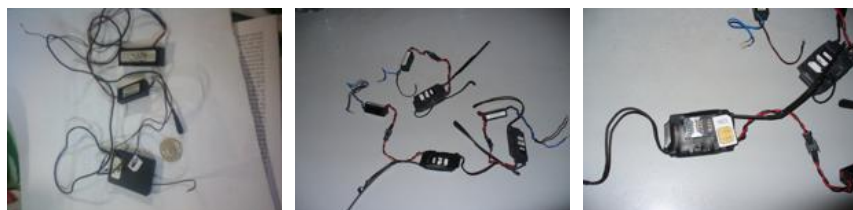
**Four microphones** were found in two homes. In the first home, a microphone was located **next to the office where there was a computer** (for some time, the loudspeakers connected to this computer were disrupted by an interference similar to the interference of a phone receiving a call), another **in the outlet next to the kitchen table**, and the last one **in the bedroom, in the outlet closest to the bed** (the outlet cover had been pierced to direct the microphone towards the headboard). In the second home, a microphone was located **in the bedroom, in the outlet closest to the door** leading to the kitchen, so that it covered several rooms. The first home's microphones included a transformer and antennas with a printed circuit board. The second home's microphone included two transformers and an antenna.

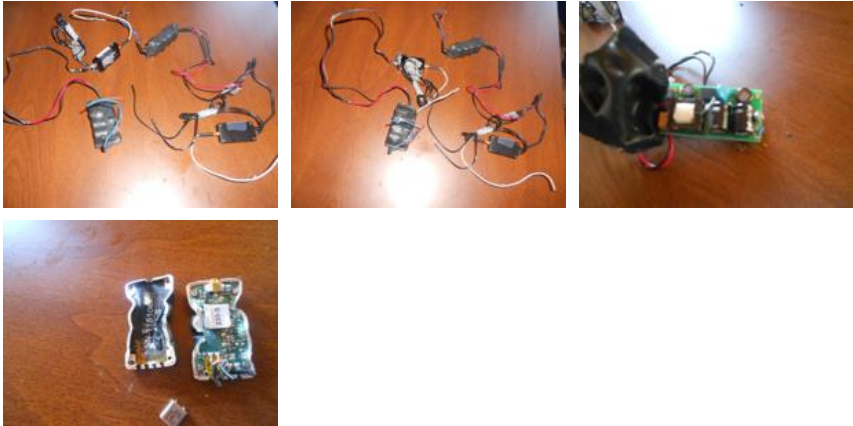
**Microphones** were found in a building.

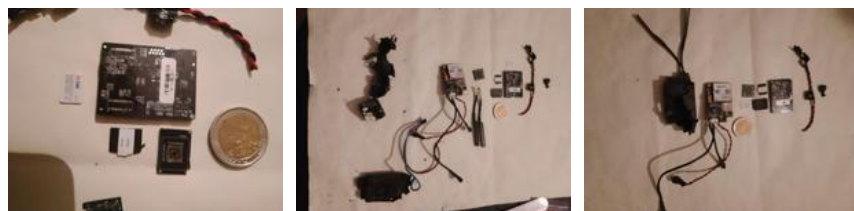
A **microphone** was found in a building. It was located **inside a power outlet**. It was equipped with a microphone, two antennas, a SIM card, a memory card and a battery.

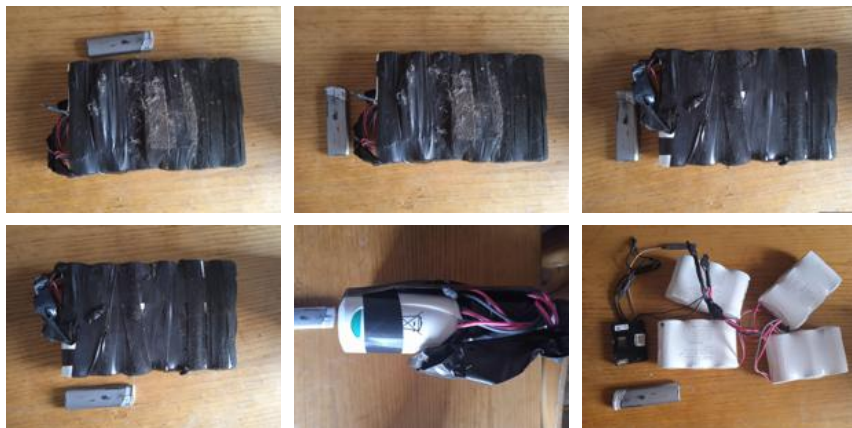
A **microphone** was found in a house.

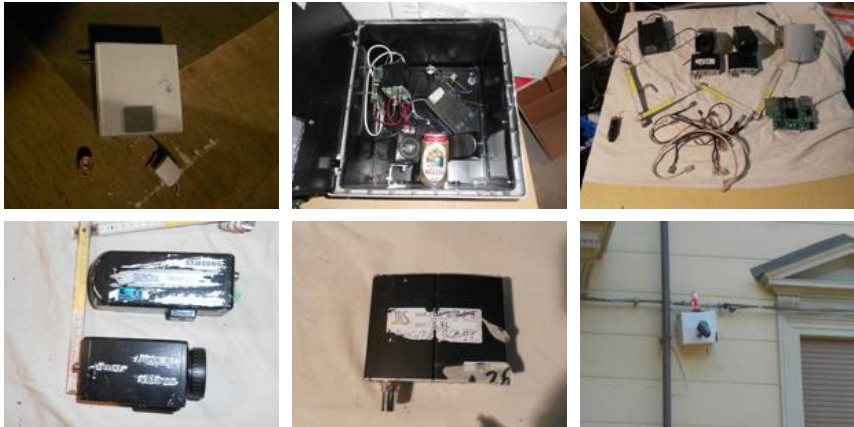
The box were the cameras were found

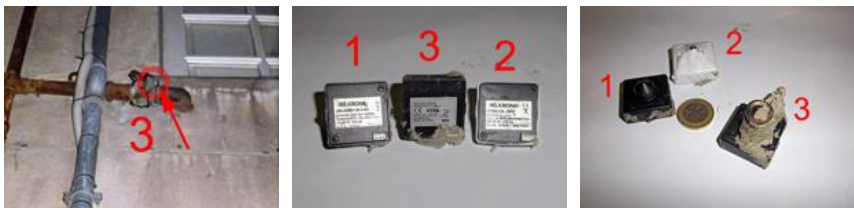
The pictures of the devices show that the cameras were marketed by the Italian company Elkron (which became a subsidiary of the Italian company Urmet in 2012). This suggests that the cameras were supplied by the Italian company **Elkron**.

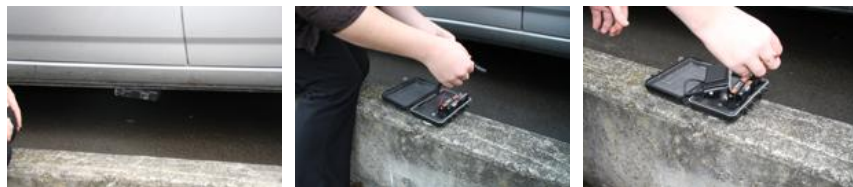
- GT2000.pdf:<sup>19</sup> product description of the GT-2000 device (in English).
- levin-2010-04.zip:<sup>20</sup> very high resolution pictures of the device.

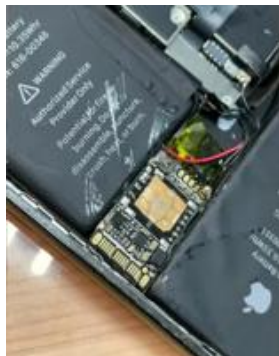
A **surveillance device** was found **inside the smartphone** of the campaign manager of a Russian anti-corruption activist. It included a SIM card, a microphone, a GPS tracker, and a microcircuit to amplify the radio signal. Some of the phone components were modified to make room for the surveillance device. The device was installed when the owner of the phone was in custody and her phone confiscated. The device was probably installed by the FSB (“Federal security service”).

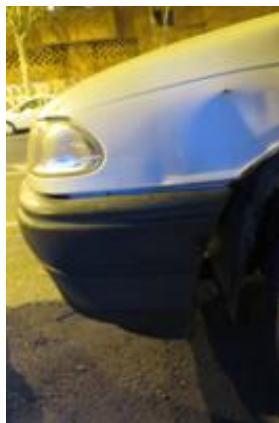
GSM antenna, and a SIM card. Its components were wrapped in black tape and magnetically mounted to the car mudguard and frame. It was probably installed by the *Cuerpo Nacional de Policía* (Spain national civilian police force).

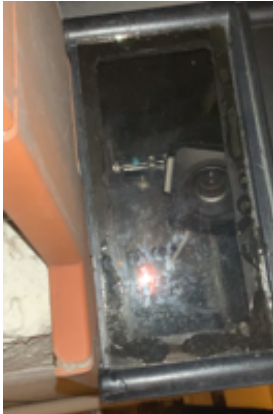
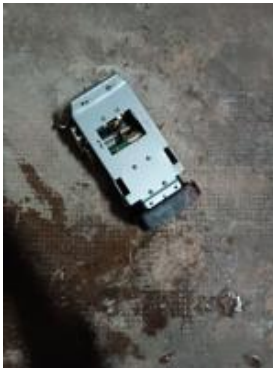
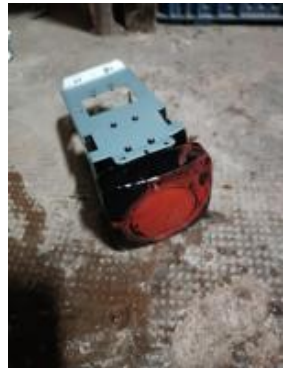
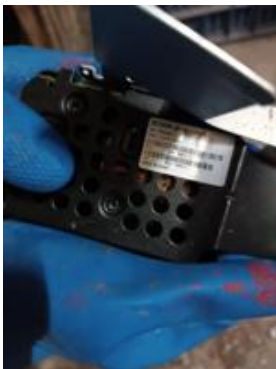
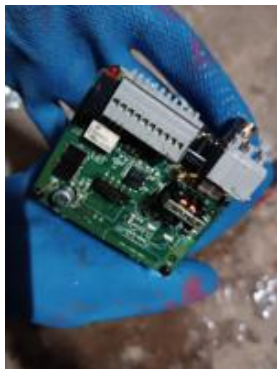
A **camera** was found in front of a house. It was located **inside a black box, on the roof of a restaurant located in front of the house.**

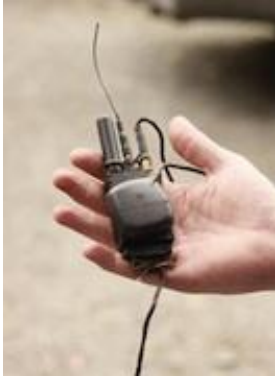
A **GPS tracker** was found under the car of an Irish republican. It was located **inside the car's rear bumper** and **attached to the vehicle with magnets**. Shortly after the device was discovered the car was seized by the police, and returned to the owner after a number of hours.

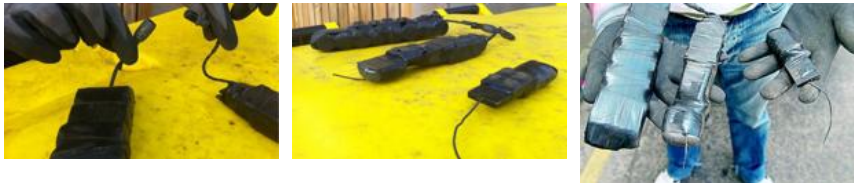
A **GPS tracker** and a **listening device** were found on the car of an Irish republican. Parts of the device—battery packs and a transmitter—were hidden **behind the car rear bumper**.

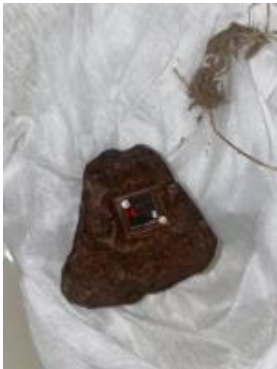
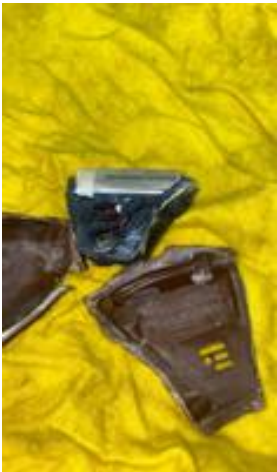
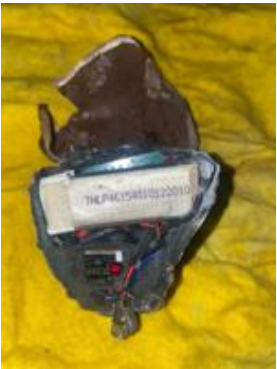
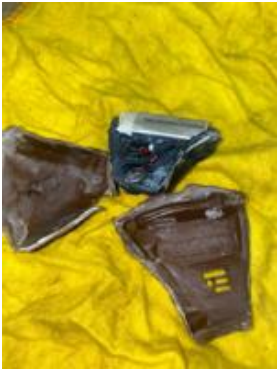
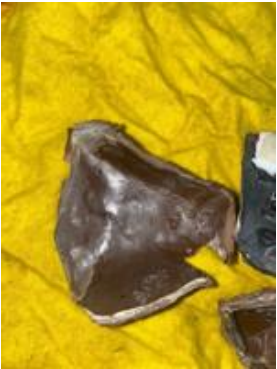
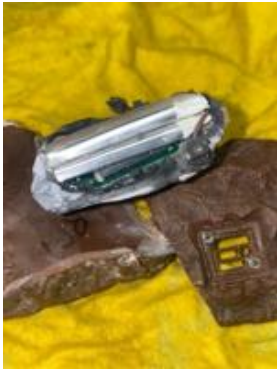
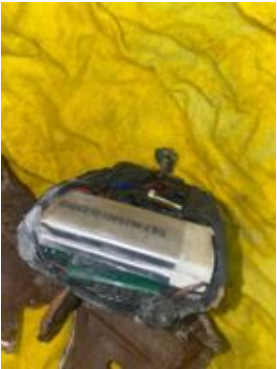
A **listening device** was found outside. It was **disguised as a rock**. It contained two microphones.

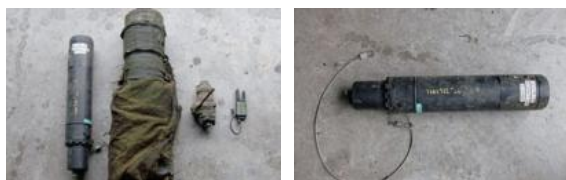
**Three surveillance cameras** were found overlooking a restaurant. They were **buried in a hill** at a certain distance from the restaurant. They included a transmitter and a battery pack.

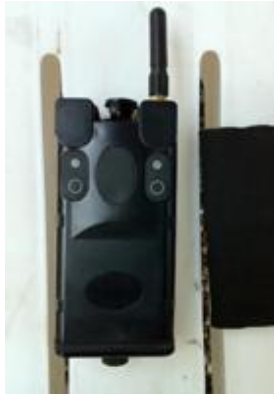
First tracker, out of its sleeve

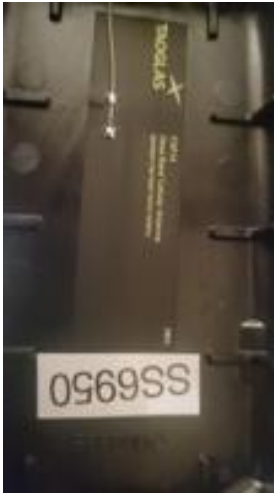
A **tracking device** was found on a truck. It was **attached with a magnet to the frame of the truck**.

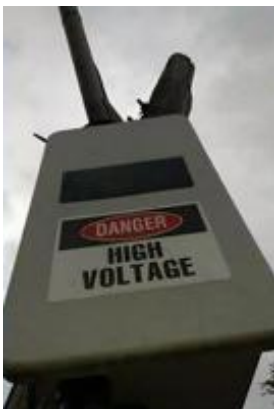
A **camera** was found in front of a home, in a **box** installed on a **power pole**.
