# Ears and Eyes

Without Pictures

*Ears and Eyes* is a searchable database of cases of physical surveillance devices (microphones, cameras, location trackers...) hidden by law enforcement and intelligence agencies to surveil people or groups engaged in subversive activities.

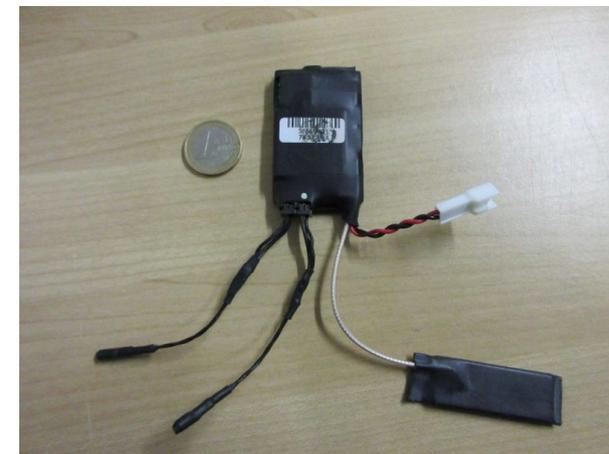
Microphones found inside a power outlet in a building in Bologna, Italy, in January 2018.<sup>1</sup>

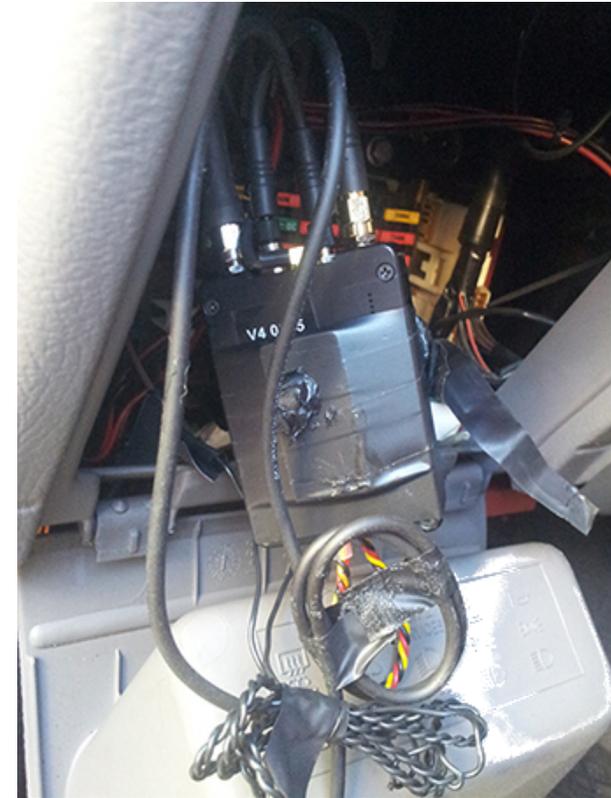
Microphones and a GPS tracker found in the fuse box of a car in Lecce, Italy, in December 2017.<sup>2</sup>

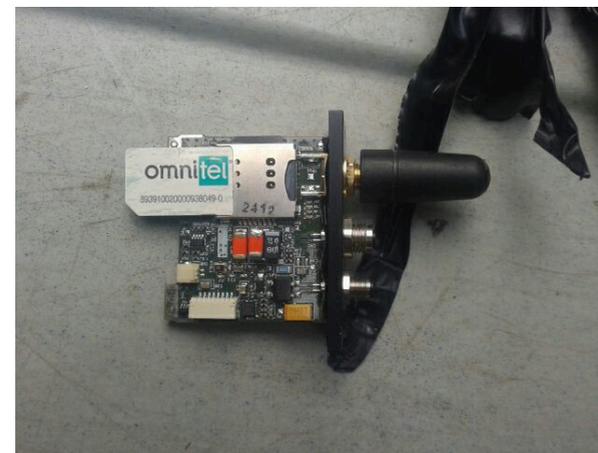
A device equipped with a SIM card found in a vehicle in Italy, in August 2019.<sup>5</sup>
