Ears and Eyes

With Pictures

Ears and Eyes is a searchable database of cases of physical surveillance devices (microphones, cameras, location trackers...) hidden by law enforcement and intelligence agencies to surveil people or groups engaged in subversive activities.

Italy-Unknown country

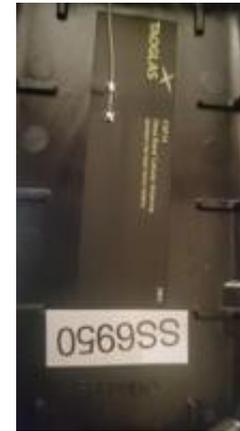
Lecco, April 2010

A **GPS tracker and a microphone** were found in a car. The device was located **between the car body and the interior coating, attached with two magnets**. It was connected to the car power

supply by the car interior light wires. It consisted in a modified mobile phone, an antenna, a GPS and a microphone.

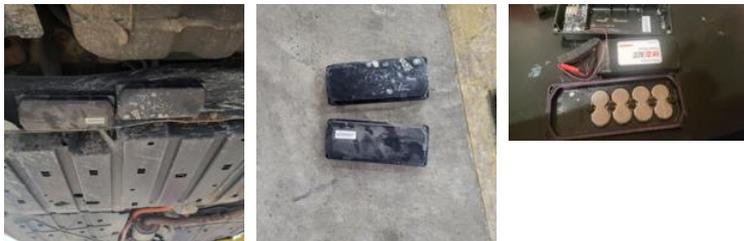
A **tracking device** was found under the car of someone who had been arrested two days earlier on an outstanding warrant. It was **attached under the rear axle of the car with strong magnets**. The device included a battery, a cellular antenna and a SIM card.

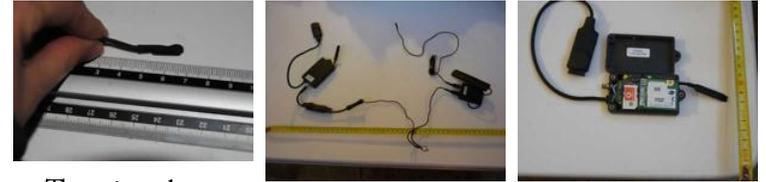
The microphone

The whole device

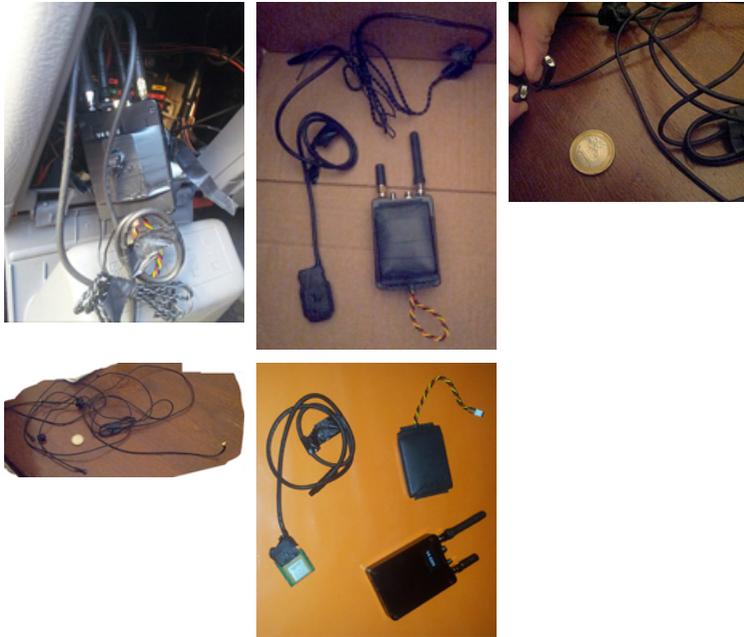
Microphones and a GPS tracker were found in a car. They were located **in the fuse box**. The car had been having electrical problems (the battery had discharged twice in a month, sign of an abnormal electricity consumption), presumably because of the devices.

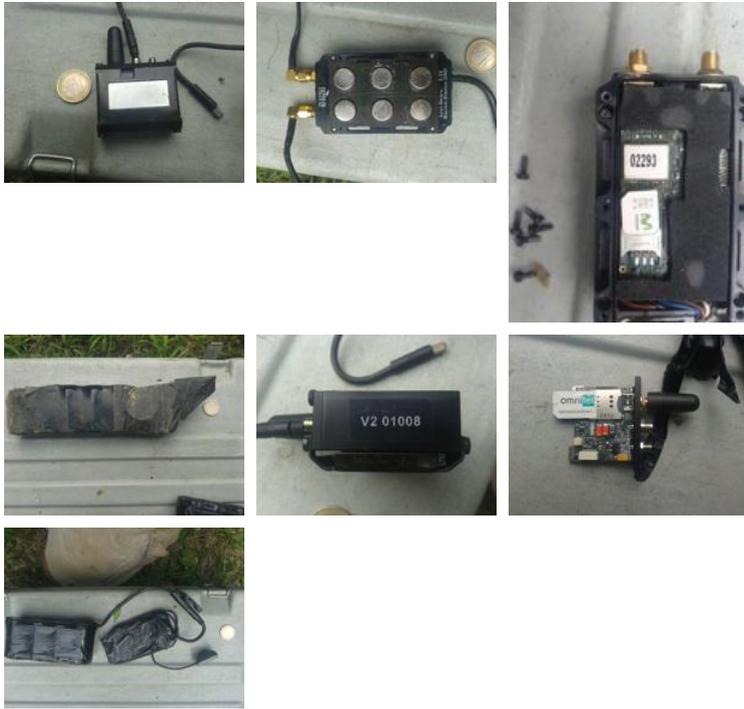
A **microphone and two GPS trackers** were found in a vehicle. A first tracker was **attached with a magnet to the rear bumper, on the right side**. The other tracker, along with the microphone, was located **in the air vents located between the windscreen flap and the windscreen**. The first tracker included a SIM card and an accumulator made of five 3.6 V lithium batteries connected in a series. The other tracker was equipped with a SIM card.

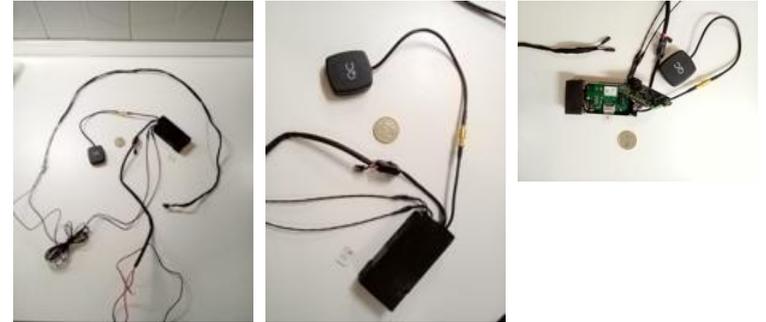
tracking device used the GLONASS positioning system, and consisted of an antenna connected to a multi-frequency receiver box containing a micro SIM card.

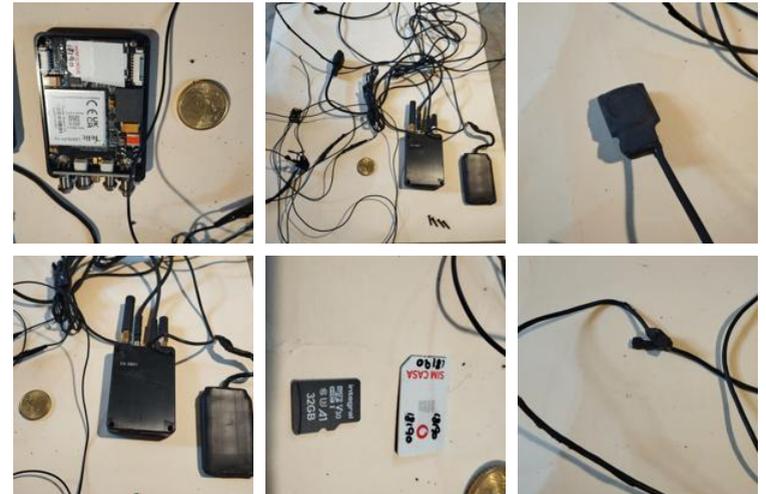
A **surveillance device** was found in a car. It was located **on the driver's side, at the bottom left, next to the seat**. It was equipped with a SIM card, a 32 GB memory card, a GPS module and two microphones, one under the driver's seat and one near the seat belt, both on the same side. It was powered by cables located under the steering wheel.

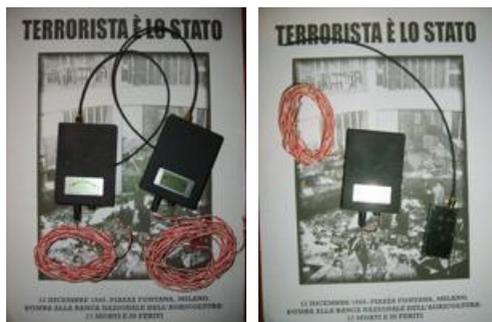
Two receiver cases were found in the entry corridor of a building. They were hidden **above a fake ceiling in the entry corridor**. They were connected to the phone line with telephone wires. They consisted in a main unit with a remote-controlled connector, a digital receiver showing the strength of the received signal, and antennas. The presence of the two receivers presumably meant that there were two emitting microphones in the building.

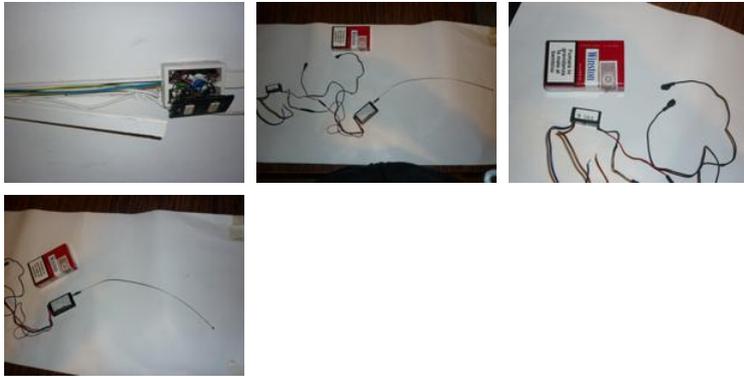
A **microphone** was found in a building. It was located **inside an electrical outlet**. It was a transmitter-receiver.

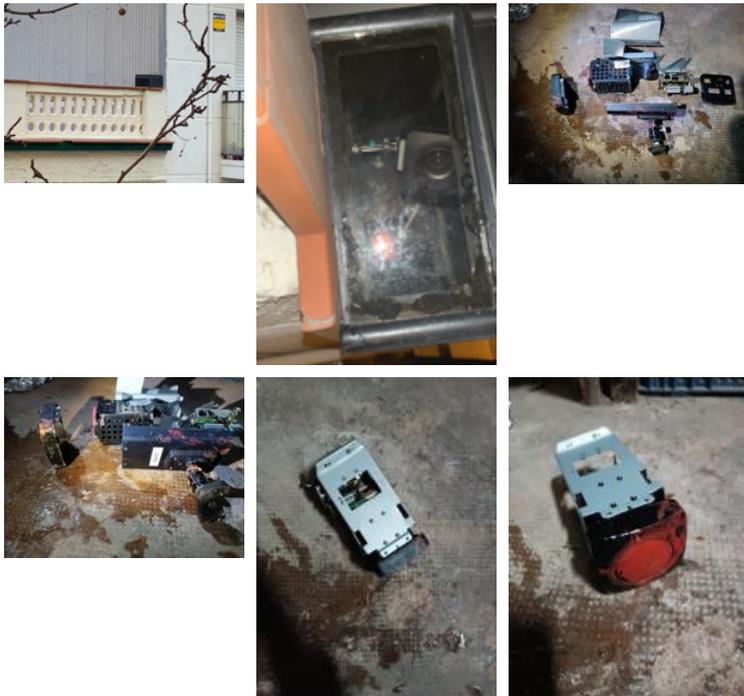
A **camera** was found in front of a house. It was located **inside a black box, on the roof of a restaurant located in front of the house.**

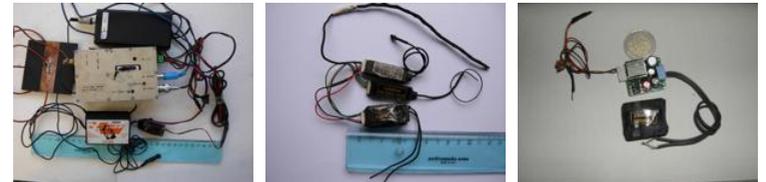
Milan, November 2010

Microphones and a micro-camera were found in multiple homes. The devices were found **in an amplifier, in the kitchen hood and in a cathode-ray television.** They included microphones and 300 MHz transmitters with ranges of 200 to 300 meters. One of the devices could be activated by remote control (at a distance of hundreds of meters). Another device came with a micro-camera linked to a UHF band transmitter.

Microphone inside the TV set

Microphone inside the cooker hood

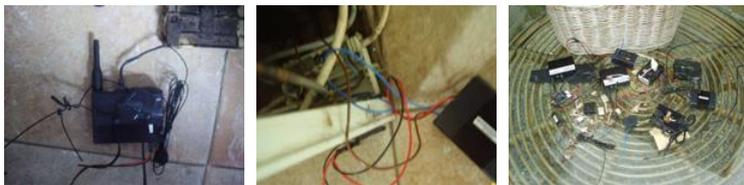
Four microphones and a camera were found in a house. A microphone was located **behind the fridge**, another **in the bedroom**, another **in a beam next to the ceiling light**, another **in the house entry**. A small camera **filmed the entry stairs**. All were connected through a transformer to the house electrical network.

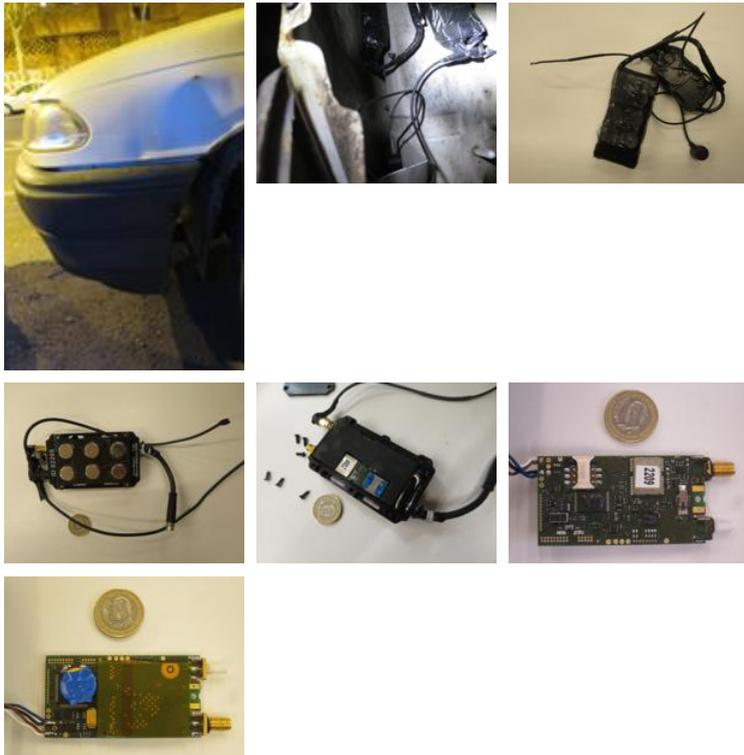
A **geolocation device** was found on a car. It was **magnetically mounted inside a wheel well of the car**. It included a battery, a GPS antenna, a GSM antenna, and a SIM card. Its components were wrapped in black tape and magnetically mounted to the car mudguard and frame. It was probably installed by the *Cuerpo Nacional de Policía* (Spain national civilian police force).

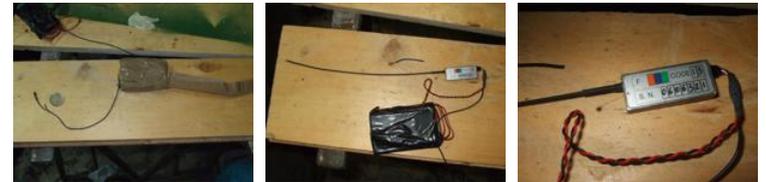
Two microphones were found in a building. They were located **in the air vents** of two rooms of the building. Each consisted in three 9-volt batteries set up in parallel, attached with tape to a transmitter microphone.

The device was like that when it was found. The microphone is next to the two euros coin and the antenna is at the other end.

The microphone without the tape and with the tip detached

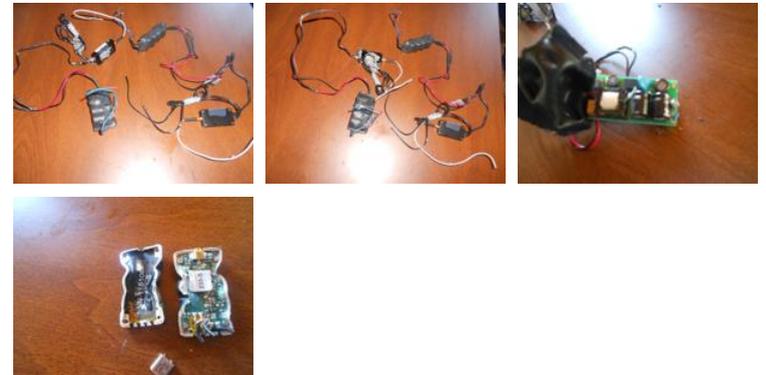
Microphones were found in a building.

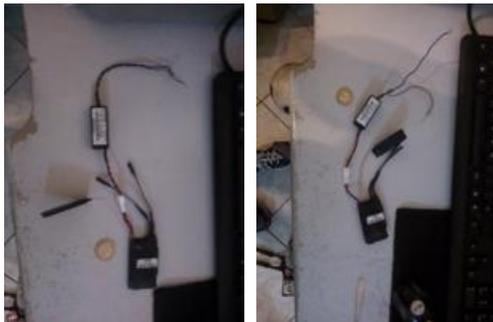
Two microphones were found in a home. The devices were **inside two electrical outlets**. Each consisted in a microphone connected to a transformer, and a thing containing a micro-SIM card.

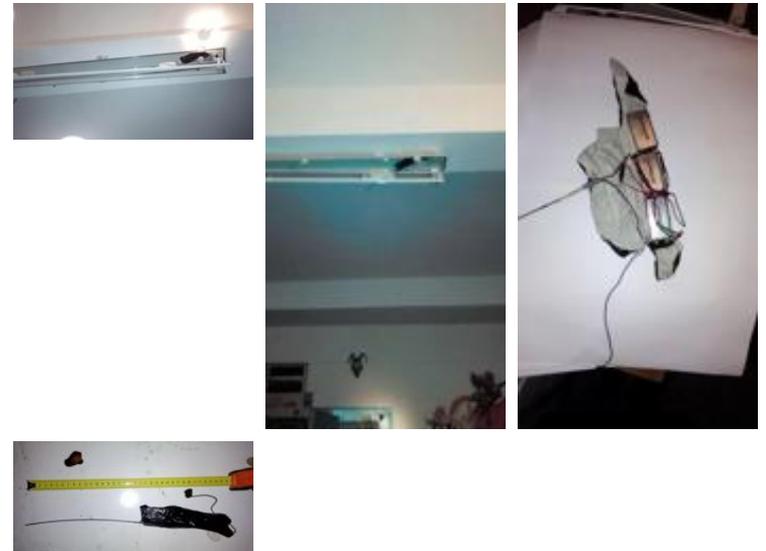
A **microphone** was found in a building. It was located **inside a neon light attached to the ceiling**. It consisted in three 9-volts batteries, joined together with insulating tape, with a microphone and antenna at each end.

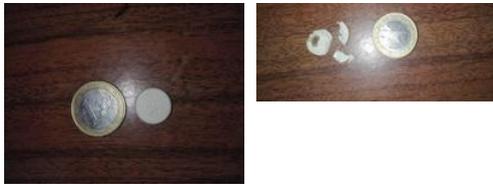
A **surveillance device** was found in a building **inside an outlet not connected to any electrical network**. The acronym “ABG” was visible on one of its edges.

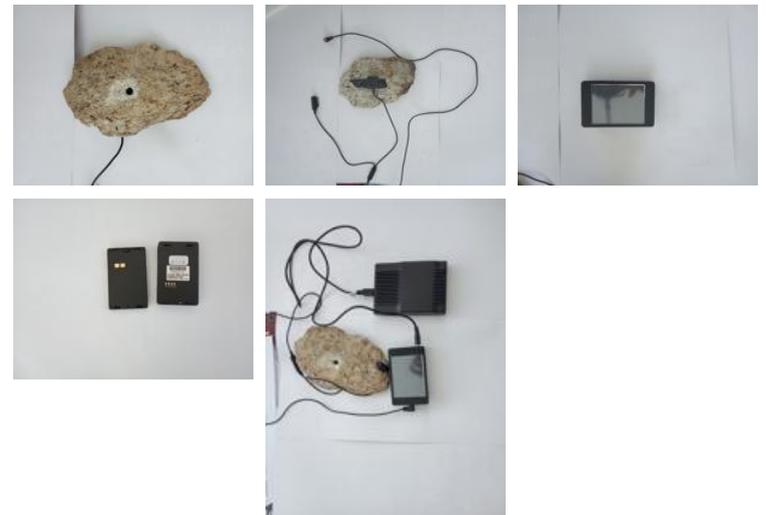
behind a few stones, in a wall along a path, wrapped in a black garbage bag. It was not the first time that a gathering took place there. The device contained a battery, a SD card, a microphone, and a camera hidden behind a rock in which a hole had been made. It seemed that the device couldn't send the recorded data, which was stored on the SD card. An analysis of the content of the SD card showed that the device was activated on June 3 and was installed on the afternoon of June 7, the day before the gathering.

The pictures of the device show that the device included a digital video recorder of model “DK-PV500E”, marketed by the Italian company DSE (Digital Surveillance Equipment). This suggests that the device was supplied by the Italian company **DSE**.

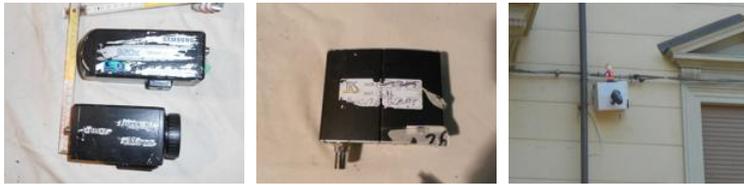
The box were the cameras were found

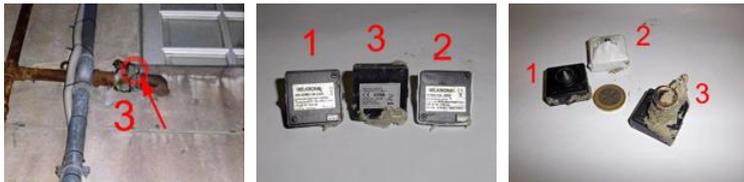
The pictures of the devices show that the cameras were marketed by the Italian company Elkron (which became a subsidiary of the Italian company Urmet in 2012). This suggests that the cameras were supplied by the italian company **Elkron**.

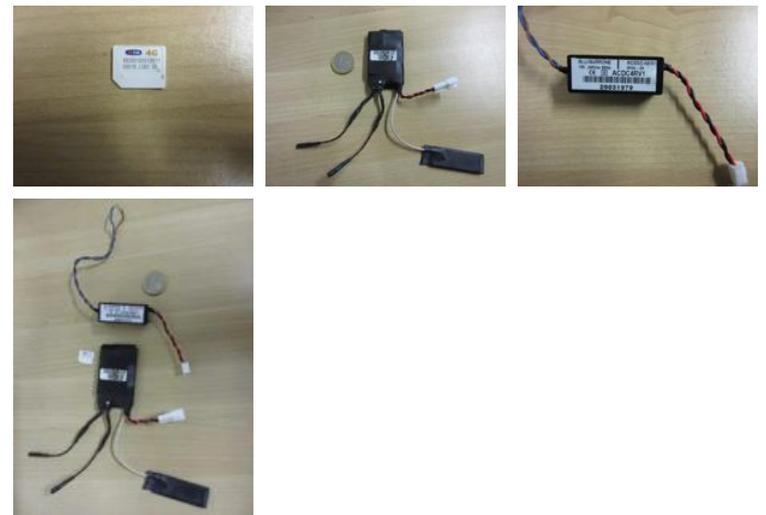
Two microphones were found in a building. They were hidden **inside a power outlet and in the junction box next to it**.

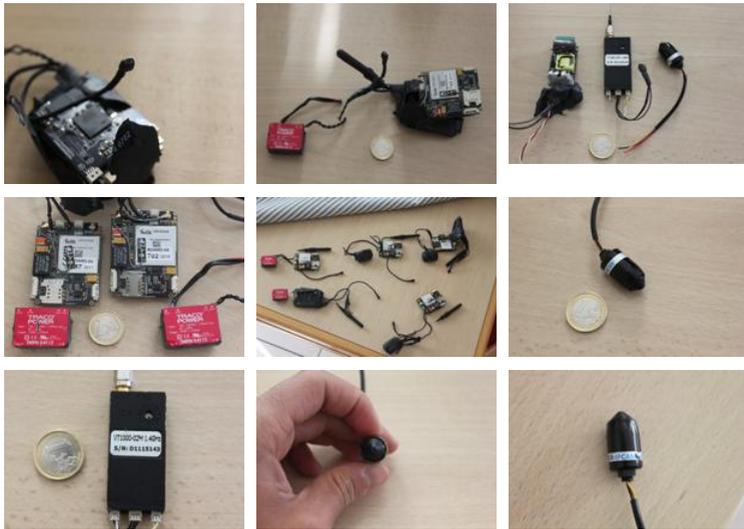
Six microphones and a camera were found in a house. The microphones were located **in electrical outlets and switch cases**, one **above the intercom in the corridor**, two other **in the living-room**, and the three last ones **in bedrooms**. The camera was located **inside the intercom in the corridor** and connected to the microphone above it. Each microphone was equipped with a battery, and, except for the one in the corridor, with a SIM card and a memory card. The camera lens could observe through a small hole already present in the intercom structure and slightly modified to fit the device.

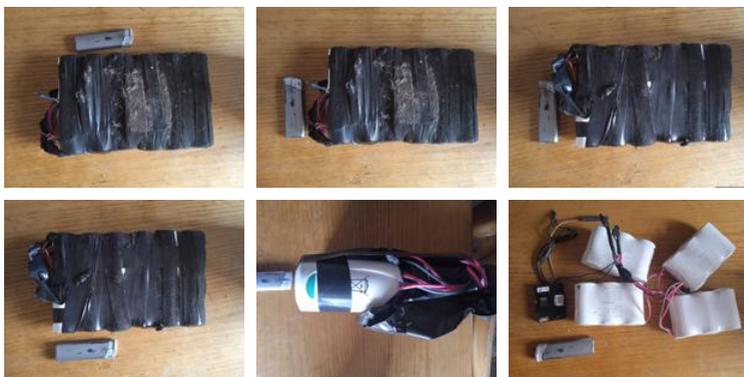
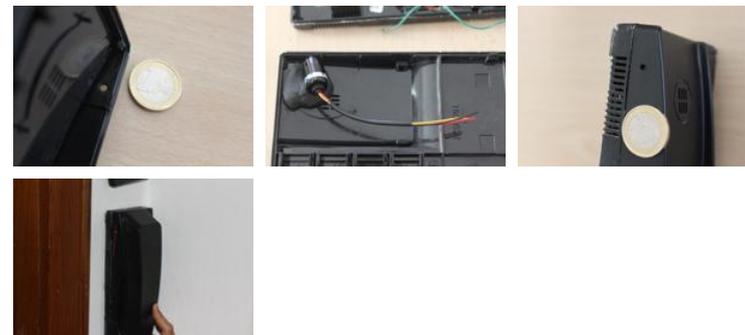
A **microphone** was found in a house.

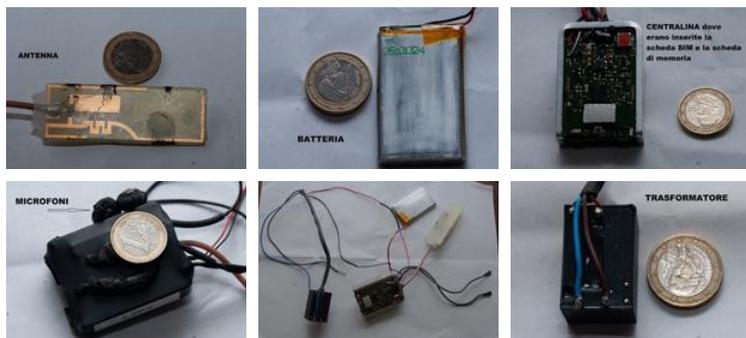
According to the source that reported the discovery of the microphones, they were supplied by the Italian company **Lutech**.

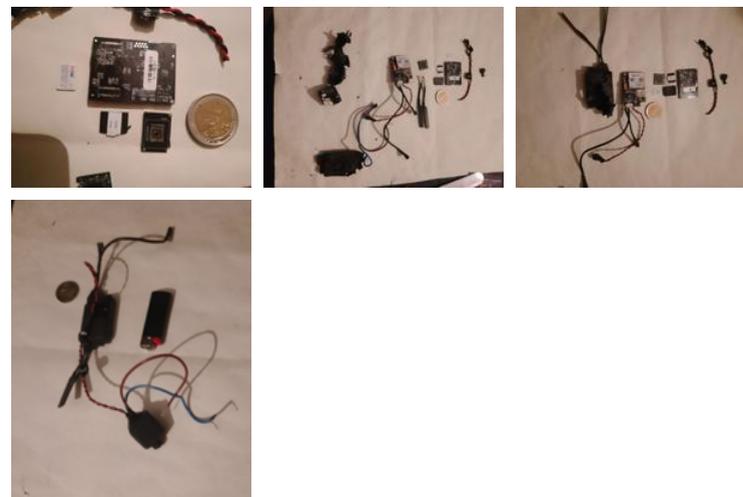
A **microphone** was found in a building. It was located **inside a power outlet**. It was equipped with a microphone, two antennas, a SIM card, a memory card and a battery.
